Ecology Report 2021

AWHITU PENINSULA LANDCARE ECOLOGY REPORT 2021
Waimatuku Case Study

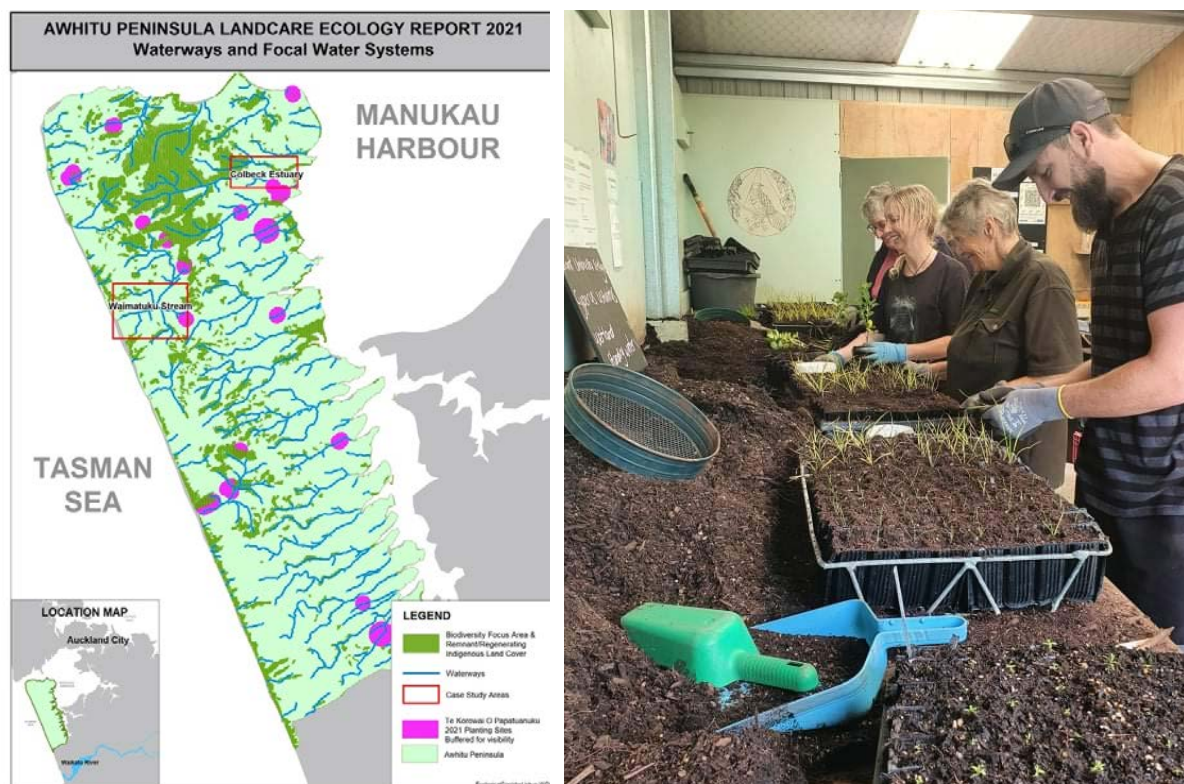
Figure 1: Map of the Āwhitu Peninsula. Waterways are a prominent feature of the Āwhitu Peninsula landscape.

A variety of plants native to the Peninsula are eco-sourced locally and grown from seed from multiple ecosystems including broadleaf and podocarp forests, wetlands and dunes. An estimated 22,000 hectares of land (figure 1) is covered in the Āwhitu Peninsula Landcare focus area, that is approximately 40km long by 8-10km wide [1].

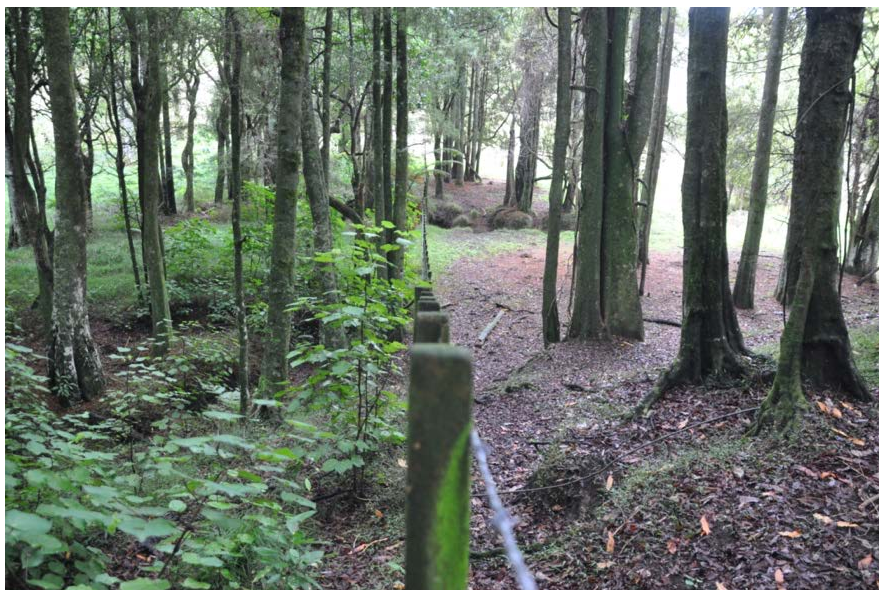
Figure 2: Exclusion of domestic livestock (Sheep *Ovis aries* and Cattle *Bos taurus*, left of fence) is essential to sustain native biodiversity in forest remnants, East Cape (Photo credit David Norton).

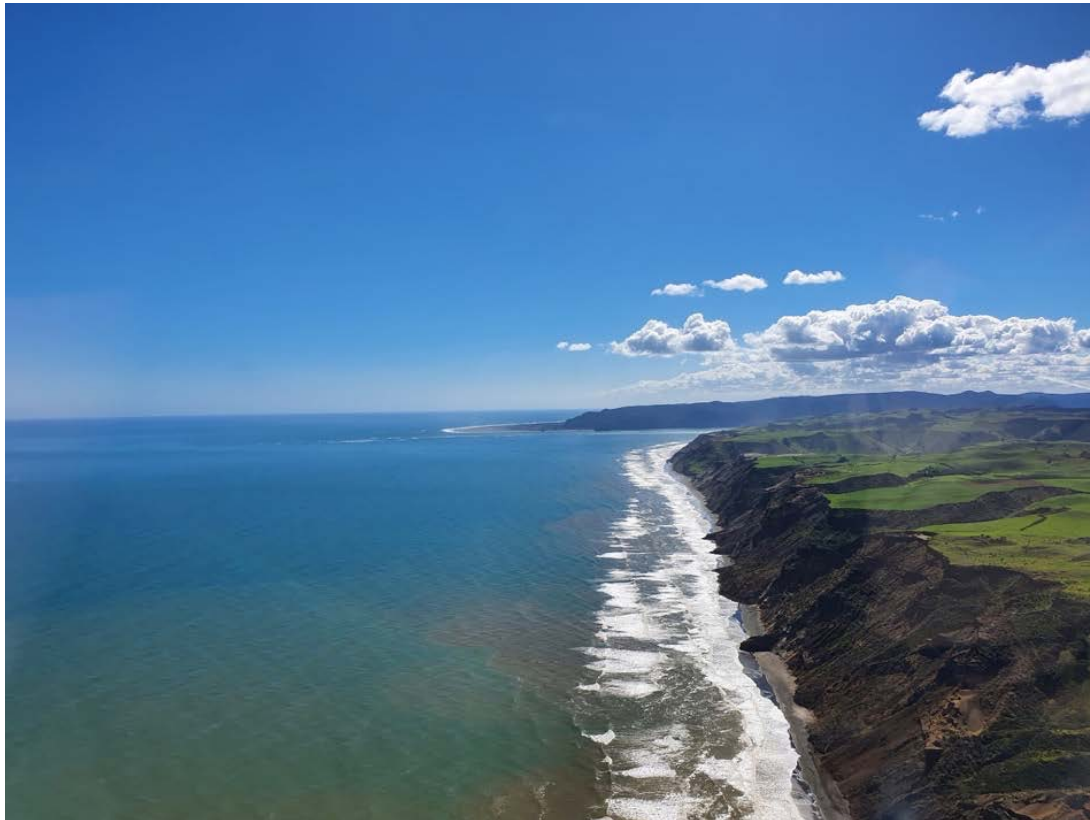
Figure 3: Photo of the western coastline. The erosion of the cliff edge is evident. Photo by Peninsula Helicopters.

that dramatically transcend down to black iron-rich sand. The west coast is prone to high wave action that accelerates erosion of the exposed cliff edge (figure 3). The eastern and northern sides of the Peninsula envelop the Manukau Harbour and are comprised of calm, white-sand beaches.

The west coast of the Peninsula is dominated by 200m sand dunes that cascade down to the black sand beach (figure 3). The dunes are prone to sand blows and the cliff edges regularly landslide. Across Aotearoa 192 million tonne of land is estimated to be lost each year into waterways and the ocean from erosion. Of which, 44% is from farming pasture [30]. Aotearoa makes up an estimated 0.1% of the global land mass, yet it contributes 1-2% of annual average yields of ocean sedimentation. The naturally high occurrence of erosion is due to high levels of rainfall, geology, tectonic activity and topography [22].

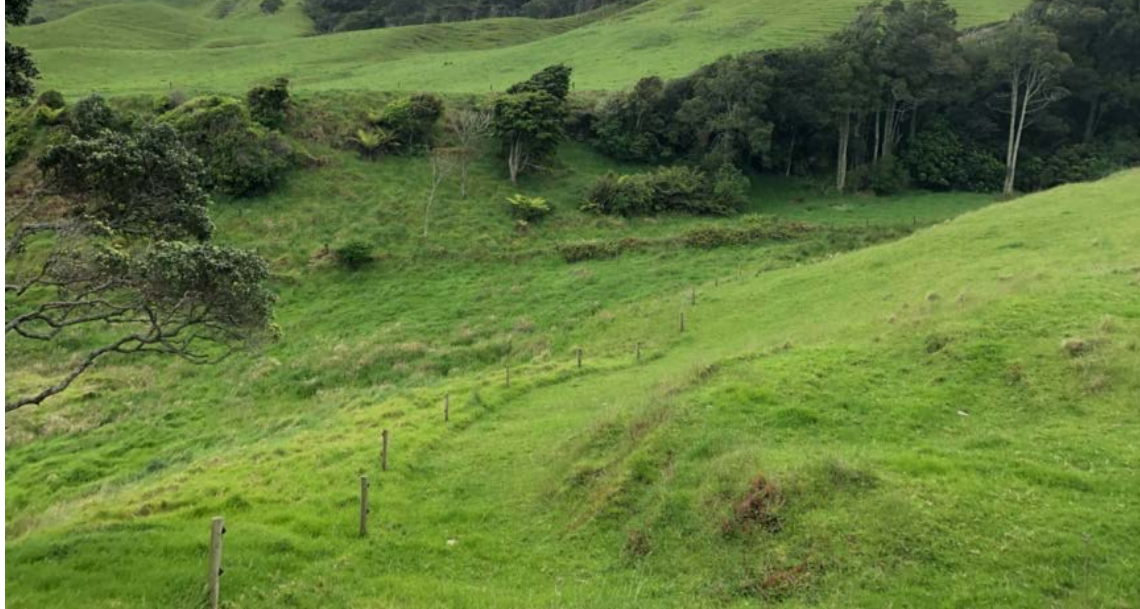
Figure 5: An area that has been fenced off and would benefit from being planted with riparian plants and would connect to established native forest.

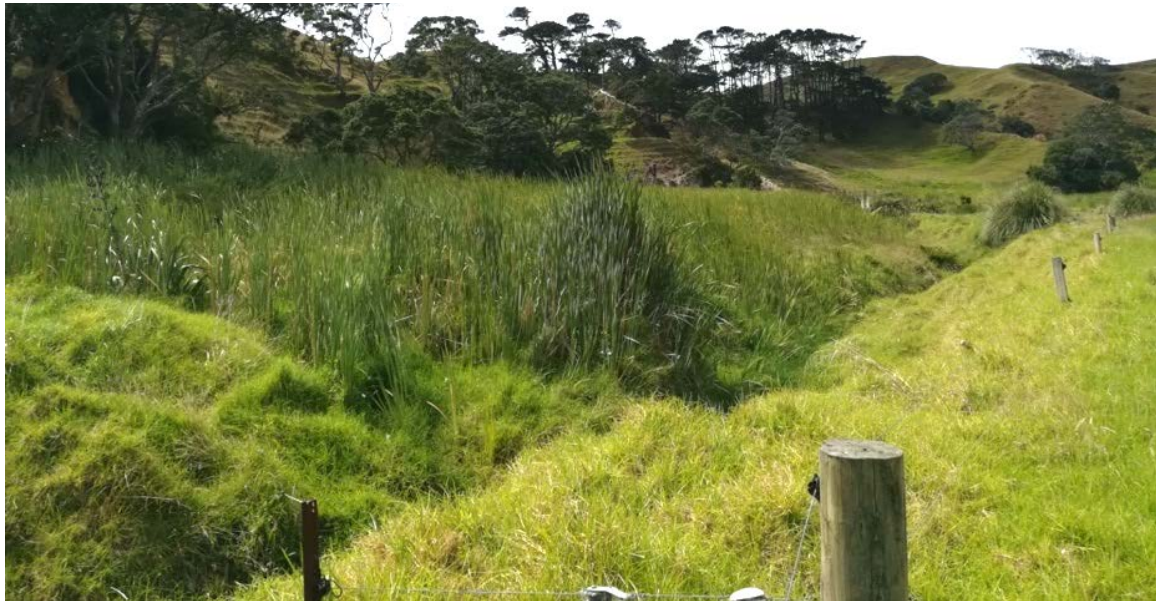
Figure 7: View from private land owner's property looking a wetland that has been fenced with electric wires ready for weed control and planting.

Across the public road there is another smaller valley containing three wetlands that are partially fenced (figures 4 and 7) by the landowner. The fencing needs to be finished, weeds managed and then it is ready for riparian planting. The landowner intends to implement this by 2024. If the wetlands are protected and enhanced with riparian planting, it would provide an effective stepping-stone connectivity for generalist fauna and wetland species. A potential corridor is depicted in figure 4 that would further enhance the connectivity to established native bush further up the valley.
